Re: November 2016 Monthly Progress Report  
Administrative Settlement Agreement and Order on Consent for Removal Action  
U.S. EPA Region 10 Docket No. CERCLA 10-2009-0255  
Gasco Sediments Site within the Portland Harbor Superfund Site

Attachment A Monthly Visual Monitoring Report for Pilot Cap Vicinity

# Visual Observations Log Form

**Project:** NW Natural – Gasco

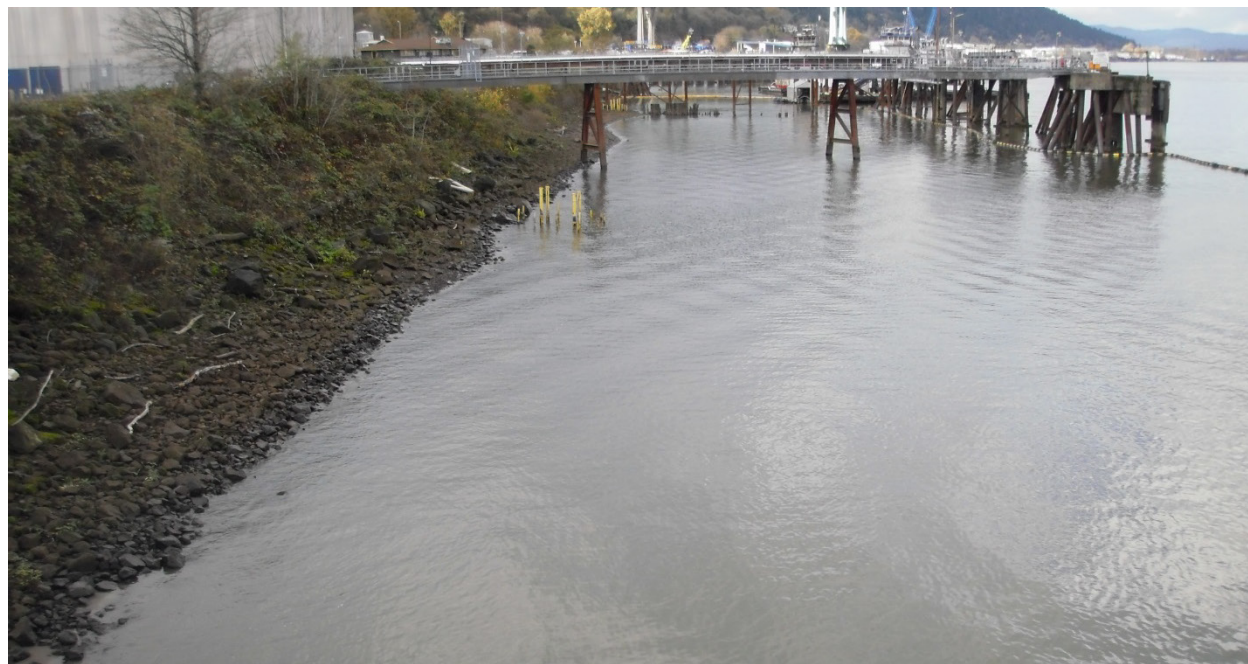
**Photo 1**

No erosion/deposition is evident along the shoreline. The shoreward extent of the cap was not visible due to high river water elevation, and the organoclay mat material shoreward of the cap area could not be observed (Photo 1).

**River Level Currently Above the Extent of Sediment Cap (11/21/16)**

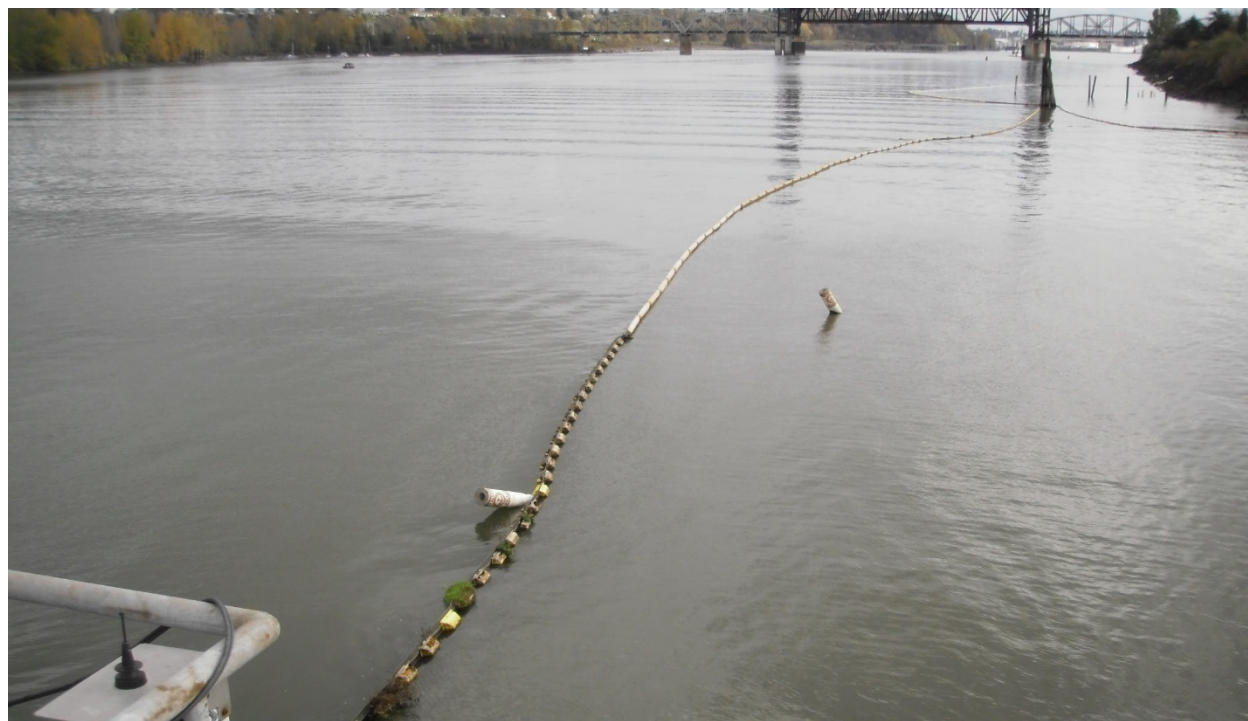
**Photo 2**

During the observation, the FAMM containment boom was placed across the cap area from the ship dock to an anchor point riverward of the upriver dolphin. Two buoys that identify the cap area to mariners are in place as installed. The positions of the FAMM oil boom and warning buoys are shown in Photo 2.

**FAMM Oil Boom Placement and Mariner Warning Buoys at Pilot Cap Area (11/21/16)**

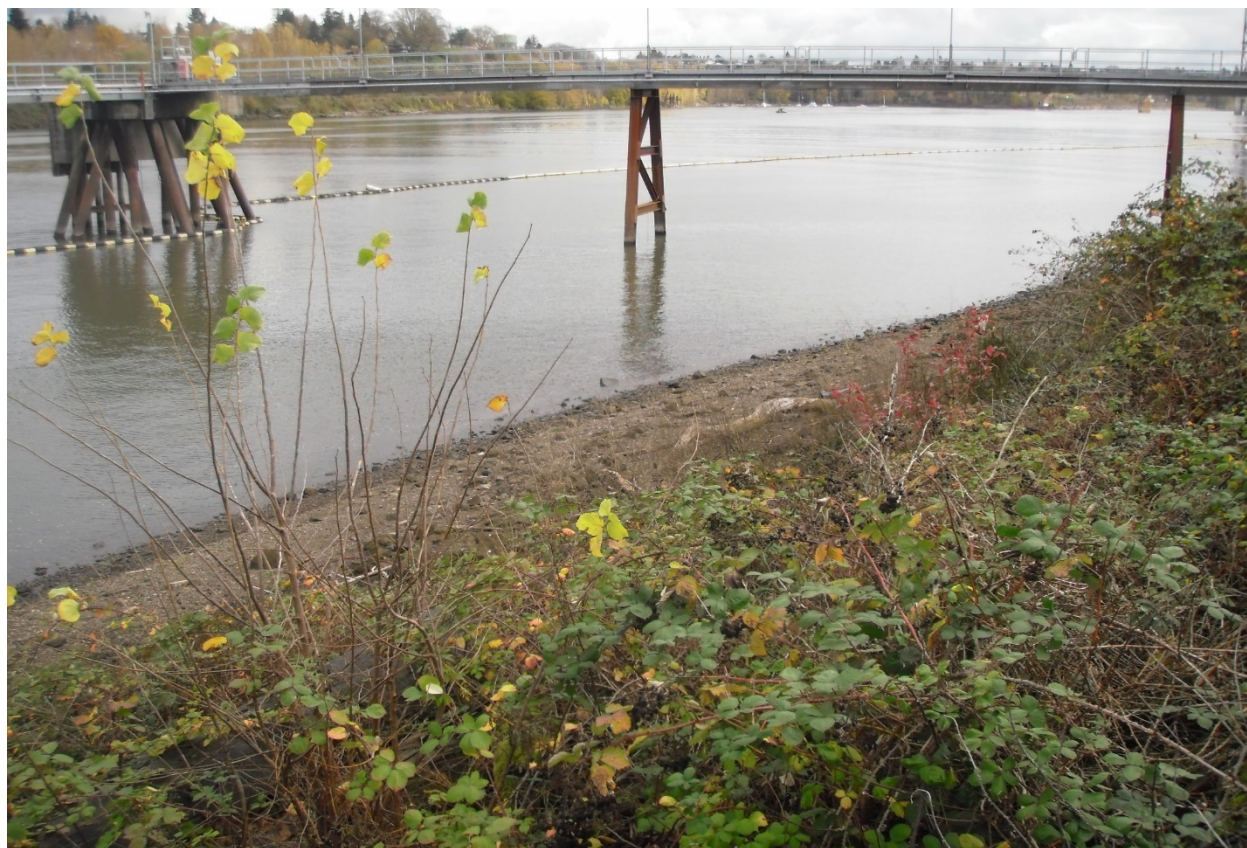
**Photo 3**

No sheen is evident in or around the cap area. Photo 3 shows the water surface and shoreline immediately downriver of the sediment cap.

**Conditions Immediately Downriver of Cap Area (11/21/16)**
